CIA/PIR-67199

CIA IMAGERY ANALYSIS DIVISION

MILITARY FACILITIES

${\tt CHIU-WENG-YUAN}$

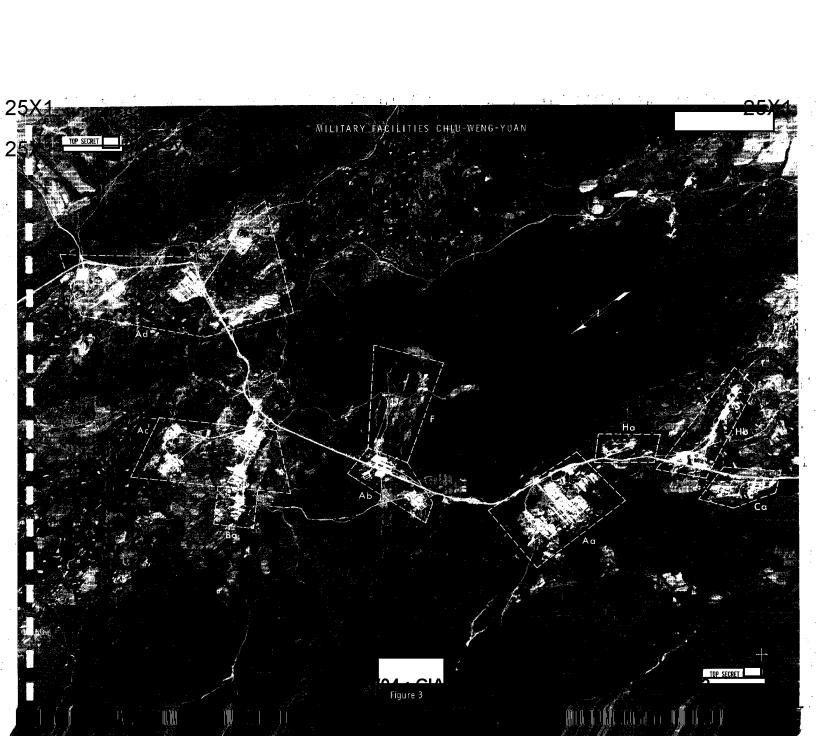
Approved For Release 2003/03/ECRET -RDP78T05161A000900010008-2	
 5X1		CIA IMAGERY ANALYSIS DIVISION CIA/PIR-67199	25X′
		3 Possible barracks under construction 2 Possible vehicle sheds under construction	
	Ba.	Possible vehicle storage/maintenance area (See Figure 3)	
		2 Possible vehicle sheds 2 Support buildings	
25X1		Not present	
	Bb.	Probable vehicle storage/maintenance area (See Figure 4)	
		2 Probable vehicle sheds 3 Possible vehicle sheds 9 Support buildings	
25X1		Under construction	
		2 Possible vehicle sheds completed 3 Support buildings completed	
		Four possible 122 howitzers and 4 cargo trucks observed in this area.	
	Bc.	Probable vehicle storage/maintenance area (See Figure 5)	
		1 Possible administration building 4 Possible barracks 11 Probable vehicle sheds 2 Possible vehicle maintenance buildings 4 Probable storage buildings 19 Support buildings Vehicles: Nine unidentified vehicles observed on

25X1		coverage. 14 Probable vehicle revetments in a semicircle are located acros	SS
		the road northeast of the main vehicle storage area.	
	care	Construction just beginning, one utility and 25 go trucks observed in the area.	
	Ca.	Probable general storage area (See Figure 3)	•
25X	' 1	6 Probable storage buildings 2 Possible vehicle sheds 5 Support buildings	25X1
20/		Area under construction 4 probable storage	20/(1
	buil	dings completed.

F.	Probable small arms/sub caliber range (See Figure 3)	
		3 Probable target runs	
	Ga.	Tracked vehicle driver training area (located approximately 4 nm	
25X1	ua.	WSW of area "Ag," partially shown on Figure 6). This area would appear to have sustained at least some recent activity on photography.	25
		Present and active.	
25X1	-	Four possible SU-76 and 4 possible T-34 tanks located near 4 probable vehicle sheds and 4 support buildings. These buildings were not present on photography.	
25X1	Gb.	Wheeled vehicle driver training area (located approximately 2 nm north of area "Ag," shown only on Figure 2).

- Not present.	
		Active.	
	Ha.	Probable support area (See Figure 3)	
25X1		ll Storage/support buildings 2 Possible vehicle sheds	
		Not present.	
	Hb.	Probable support area (See Figure 3)	
		8 Storage/support buildings

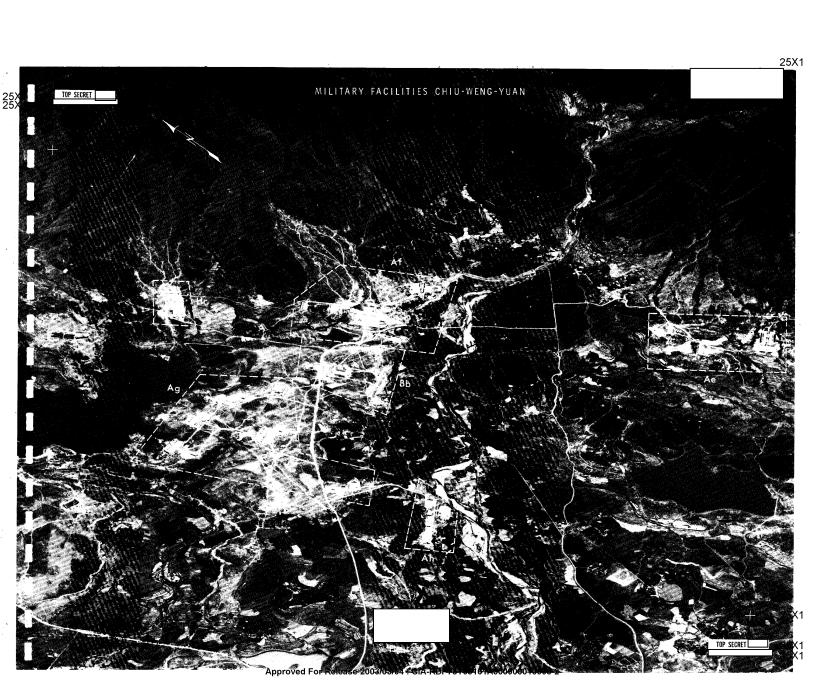
CIA IMAGERY ANALYSIS DIVISION CIA/PIR-67199
< 1		CIA IMAGERY ANALYSIS DIVISION CLA/FIX-0/199
		Area under construction
1		6 Probable barracks completed 2 Storage/support buildings completed 5 Support buildings completed 8 Probable barracks under construction
I	Ae.	Probable billeting area (See Figure 4)
		2 Possible administration buildings 4 Probable barracks 5 Possible barracks 2 Possible vehicle sheds 6 Support buildings
1		Area completed
I	Af.	Billeting area (See Figure 4)

-	2 Possible administration buildings 9 Probable barracks 1 Probable auditorium 1 Probable vehicle shed 2 Possible messhalls 10 Support buildings
1	proba	- Area completed with the exception of 4 able barracks, the probable auditorium and 2 support buildings.
P	Ag.	Possible billeting area (See Figure 4)
		6 Small possible administration buildings 8 Probable barracks 7 Possible barracks 2 Probable vehicle sheds 6 Possible messhalls 11 Support buildings
(1		
		3 Support buildings completed
P	Ah.	Possible billeting area (See Figure 4)
		2 Small possible administration buildings 4 Possible barracks 4 Possible vehicle/equipment sheds

Approved For Release 2008/S2002EGIA-RDP78T05161A00090001000	18-2
25X	(1	CIA IMAGERY ANALYSIS DIVISION CIA/PIR-6	57199
25X	1	3 Buildings under construction	25X1
	Нс.	Probable support area (See Figure 4)	
		10 Storage/support buildings 2 Possible vehicle sheds	
25X ²	1	Area completed.	
		5 Possible cargo trucks.	25X1
	posi area	Infantry training activity consisting of trenching, mortar itions and other unidentified scarring observed throughout that.	ne [.]
	SUMMARY		25X1
	photograp	fact that these military areas were not present on phy and only partially present on photography particularly when considering some of the other facts ment:	
		dispersel of the functional areas appears significant especiall part of one unit.	ally if
	An i areas "Ab	interesting pattern, possibly for small units, was observed mo," "Ac," "Ad," and "Ak." These small separated areas were o	nainly in
		pable barracks, one connected possible administration buildin and some small support buildings.

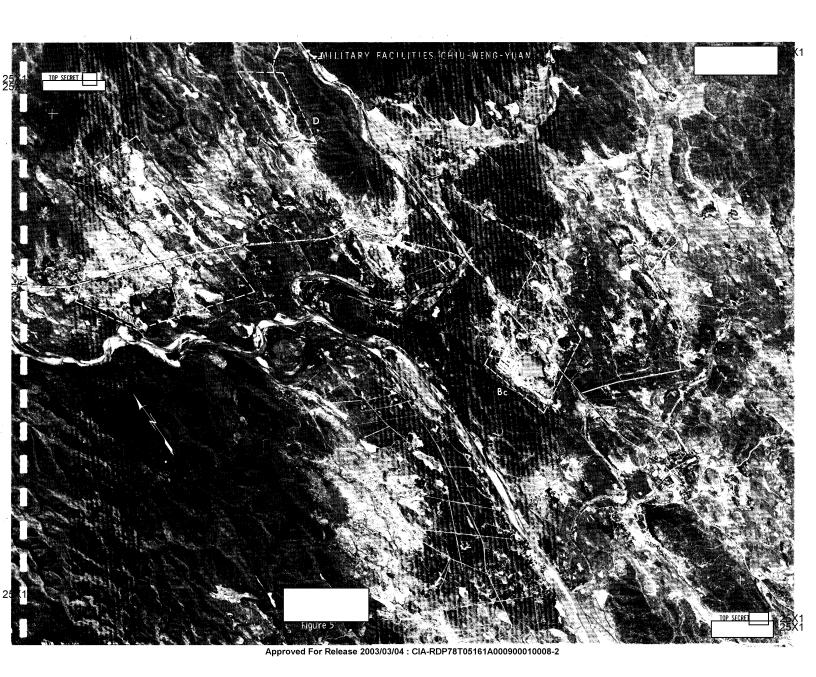
A	pproved For Release 2003/03/24ECRET DP78T05161A000900010008-2	25)
		CIA/PIR-67199	
25X1		CIA IMAGERY ANALYSIS DIVISION	
23/(1	D.	Possible explosives storage area (See Figure 5)	
		6 Possible explosives storage buildings	
		4 Support buildings

05)//		- Not present	
25X1	E.	Miscellaneous (See Figure 5)	
		4 Possible vehicles sheds 3 Unidentified buildings 12 Support buildings	
25X1		- Not covered	
		Completed
